An Archaeological Curation-Needs Assessment for Headquarters Air Combat Command

Volume 1

United States Air Force
Air Combat Command

7. PERFORMING ORGANIZATION NAME(S) AND ADDRESS(ES) U.S. Army Corps of Engineers, St. Louis District 1222 Spruce Street (CELMS-PD-C) St. Louis, Missouri 63103-2833			8. PERFORMING ORGANIZATION REPORT NUMBER Archaeological Curation-Needs Assessment Technical Report No. 10, Volume 1

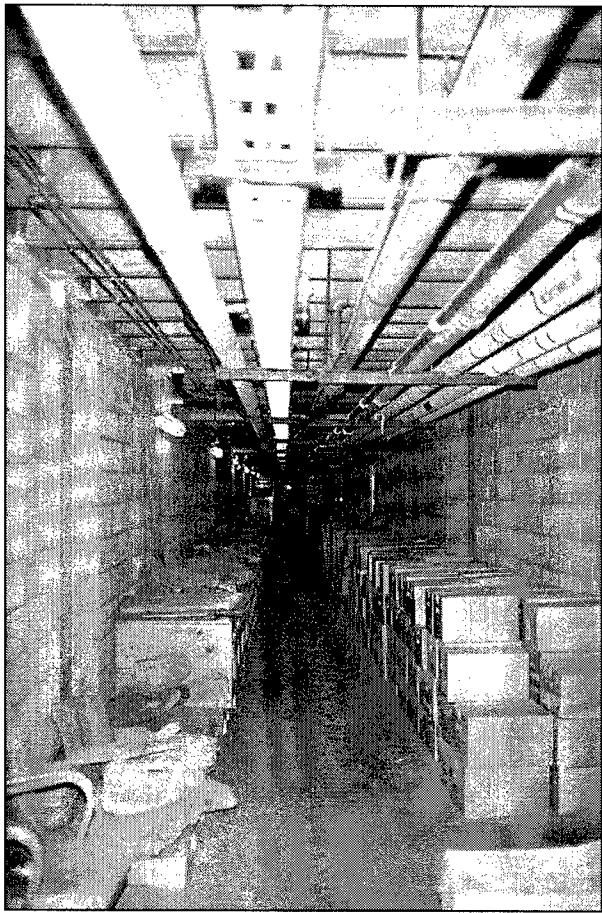
Interior basement walls are constructed of cinder blocks, and the floor in the basement is exposed concrete. The collections storage area occupies two large rooms and the hallway between them. In the rooms, there are metal and pressed plywood shelving units. Oversized ground stone is stacked on wooden pallets and housed in wooden crates that are situated in the hallway (Figure 52). Exposed pipes from the heating and plumbing systems run along the ceiling in both rooms used for collections storage and in the hallway that separates them. Many of these pipes are insulated with asbestos. The only functioning utility in the basement is electricity.

Figure 52. Ground stone is stored in the hallway between the two collections storage rooms in the basement of the LVR building.

Figure 53. Plastic has been placed over the shelves and primary containers to prevent water damage from leaking overhead pipes.

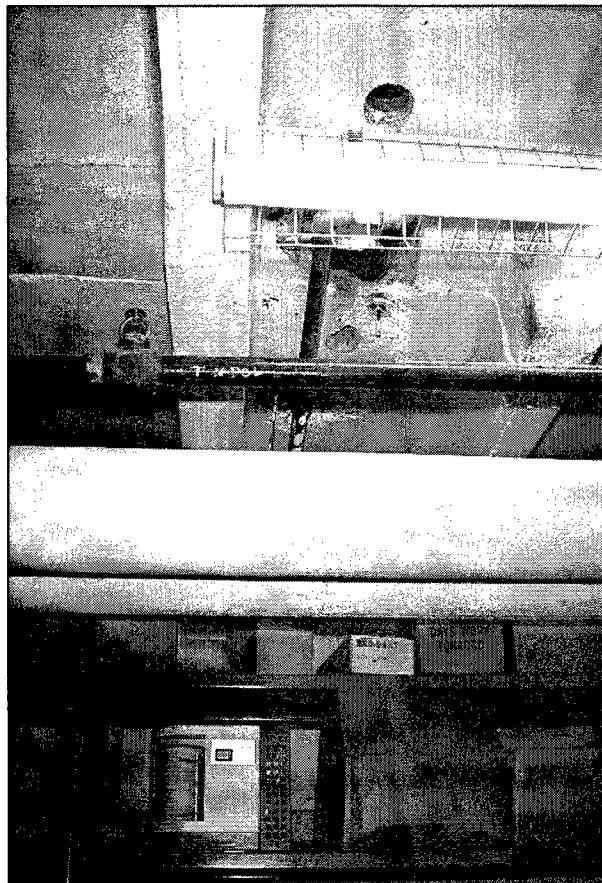
Figure 55. Hygrothermographs are located in each of the collections storage rooms in the LVR building. Also note the sprinkler system, unfiltered fluorescent lights, and holes in the concrete ceiling.

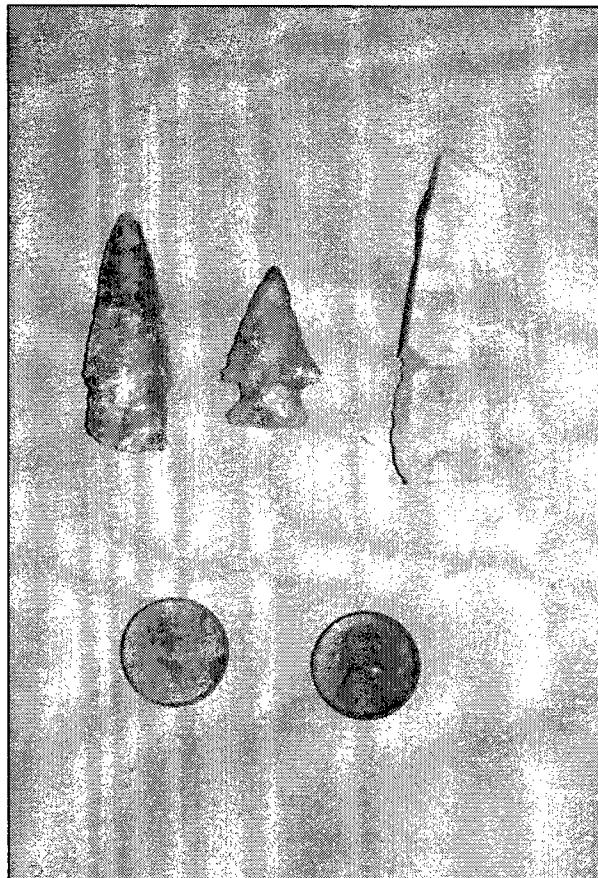
Figure 59. Artifacts from Melrose AFR have been cleaned and sorted, but none have been labeled directly in india ink.

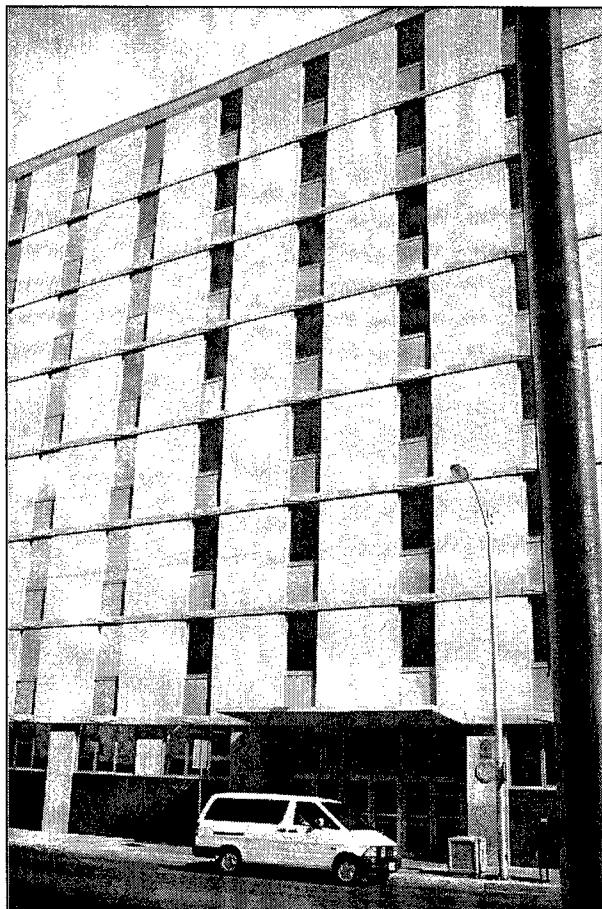
Figure 60. Exterior of the Federal Building in Albuquerque, which is considered structurally unsound.

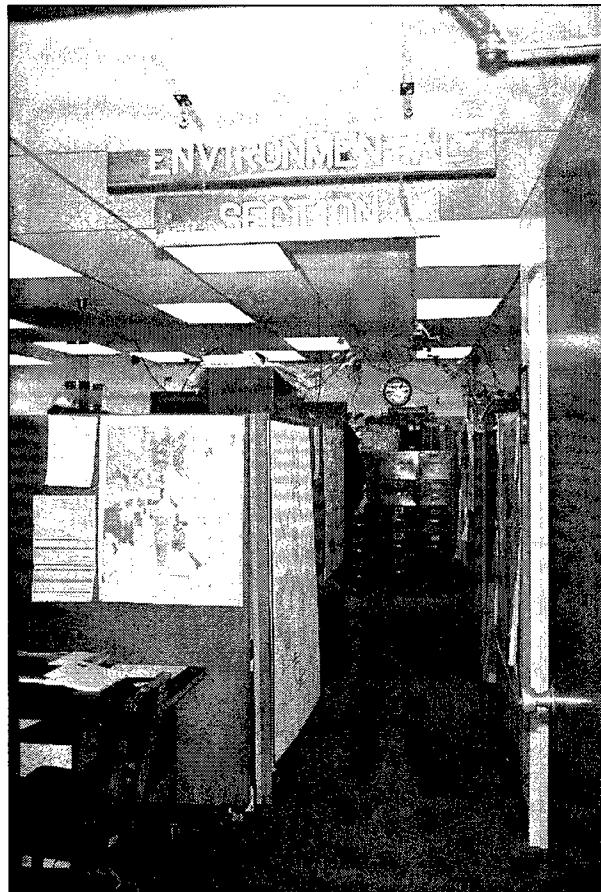
Figure 61. Entrance to the Albuquerque District, Environmental Section. File cabinets shown at the end of the aisle house most of the ACC associated documentation housed by the Corps.

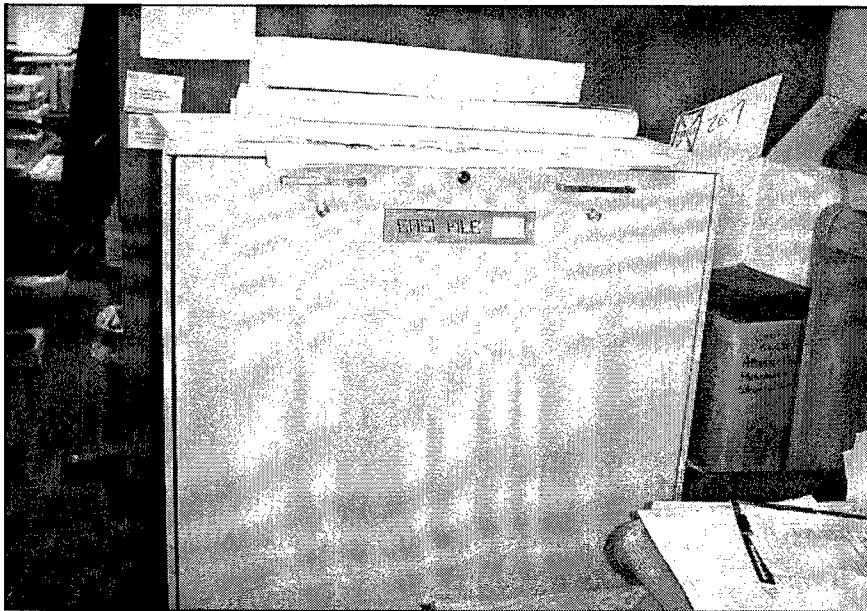
Figure 62. Maps are curated in a vertical map cabinet located in Ron Kneebone's cubicle.

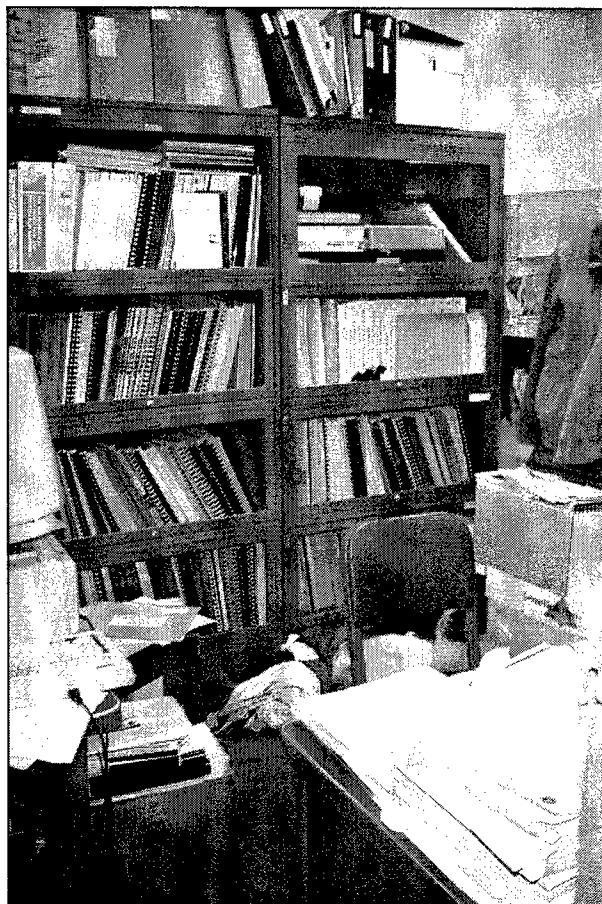
Figure 63. Reports, photographs, and compendiums are kept on enclosed metal shelves located in John Schelberg's office.

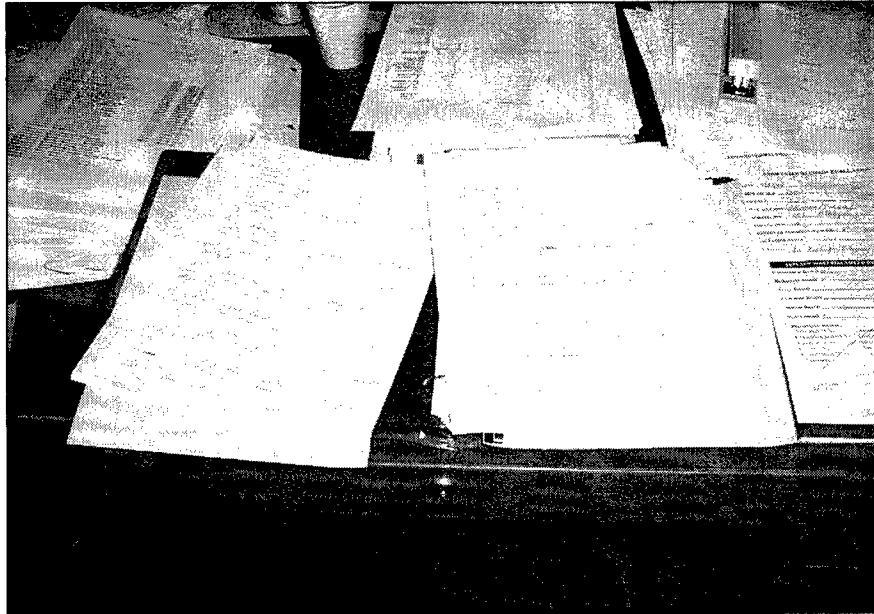
Figure 64. Associated documentation housed in a nonarchival-quality three-ring binder.

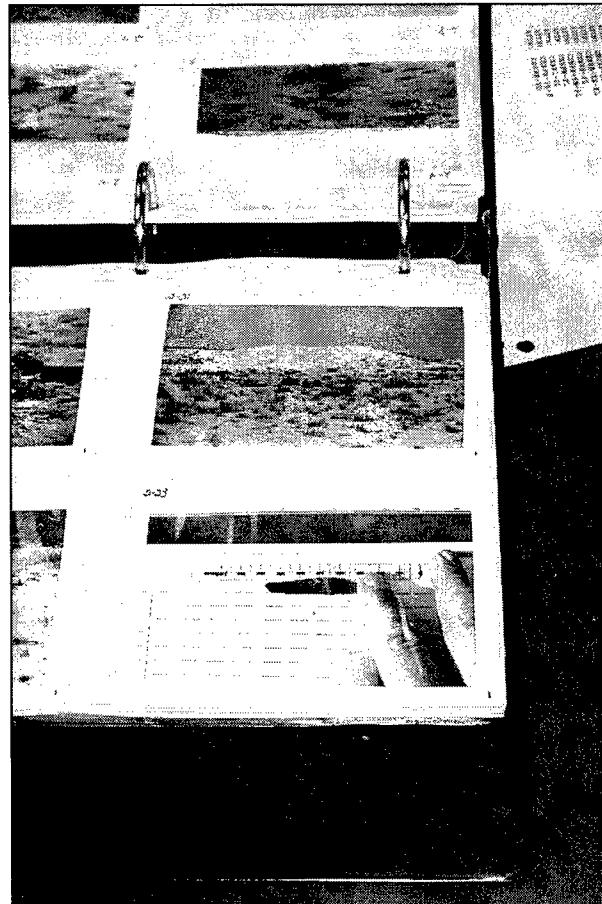
Figure 65. Photographic records are stored in nonarchival-quality sleeves that have begun to adhere to film emulsion.

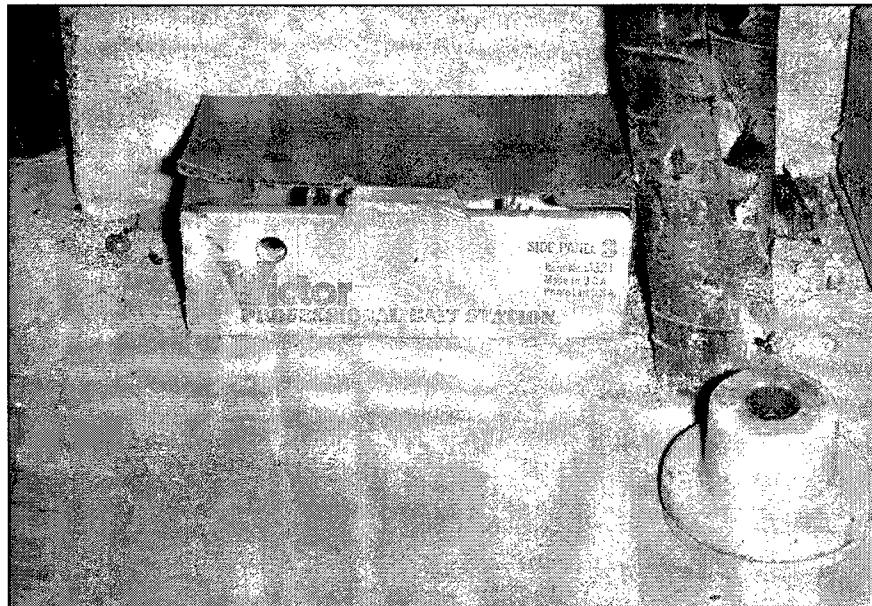
A pest-management system is also in force at the storage warehouse. The curatorial staff are responsible for monitoring the area for pest infestation and for placing rat and mouse traps in the warehouse (Figure 67). Additionally, a professional pest-management company sprays the warehouse with a pesticide twice a year.

Figure 67. Baited traps are used as the primary deterrent against pests in the Maxwell warehouse.

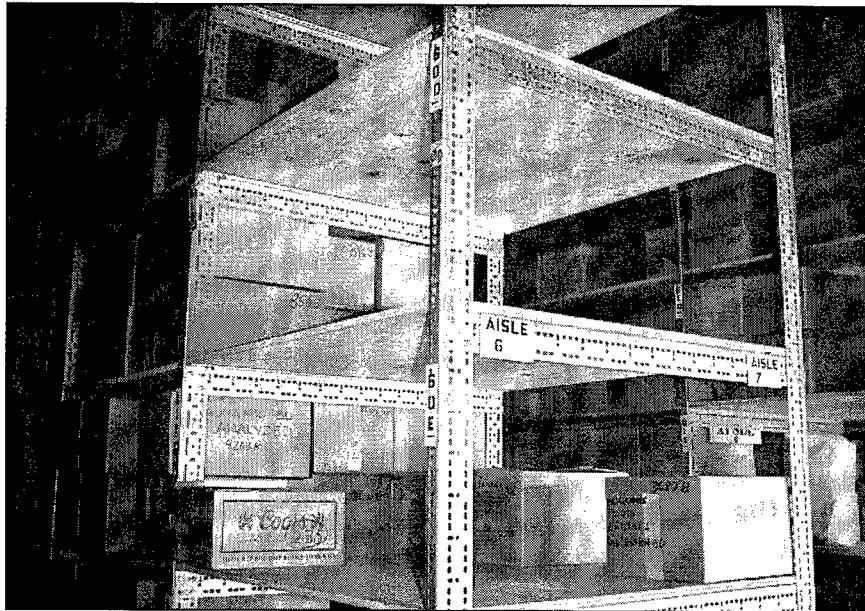
Figure 68. Metal-and-plywood shelves are the primary shelving units used in the warehouse.

Warehouse. All artifacts in the warehouse are stored on shelving units constructed of metal beams with plywood shelves (Figure 68). Each shelving unit measures 5 x 4 x 13 feet (w x d x h).

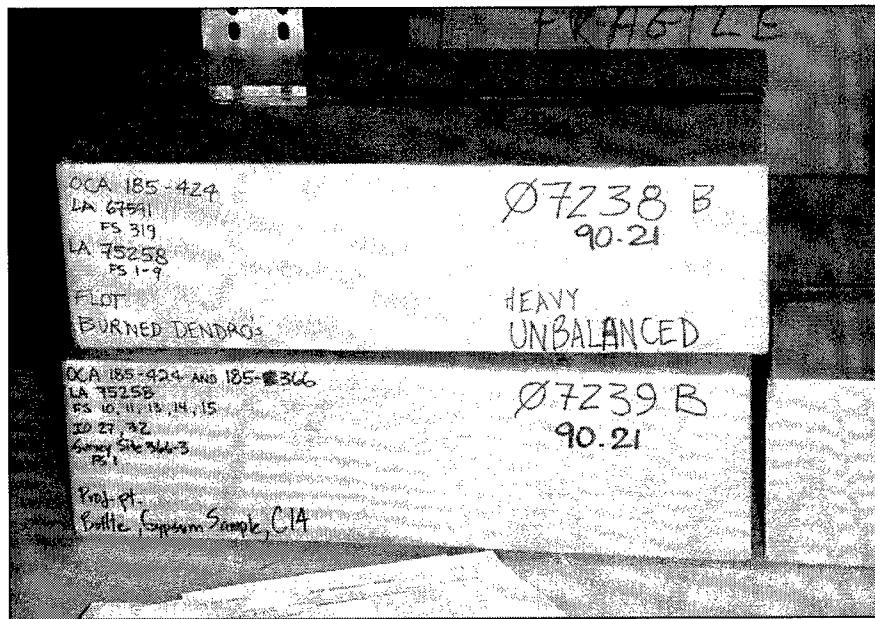
Figure 69. Labeled primary containers housing Holloman AFB collections.

Warehouse. Primary containers containing Holloman AFB artifacts consist of acidic cardboard boxes, each secured with a folding flap lid that has been taped shut. The bottom of each box has also been reinforced with nonarchival tape. Holloman AFB material is housed in four boxes that each measures 18 x 12 x 6 inches (l x w x h). Label information includes accession number, original site numbers, LOA numbers, catalog numbers, and location information. All this information is recorded directly on the boxes in marker. Labels are nonarchival, but the information is consistent and legible (Figure 69).

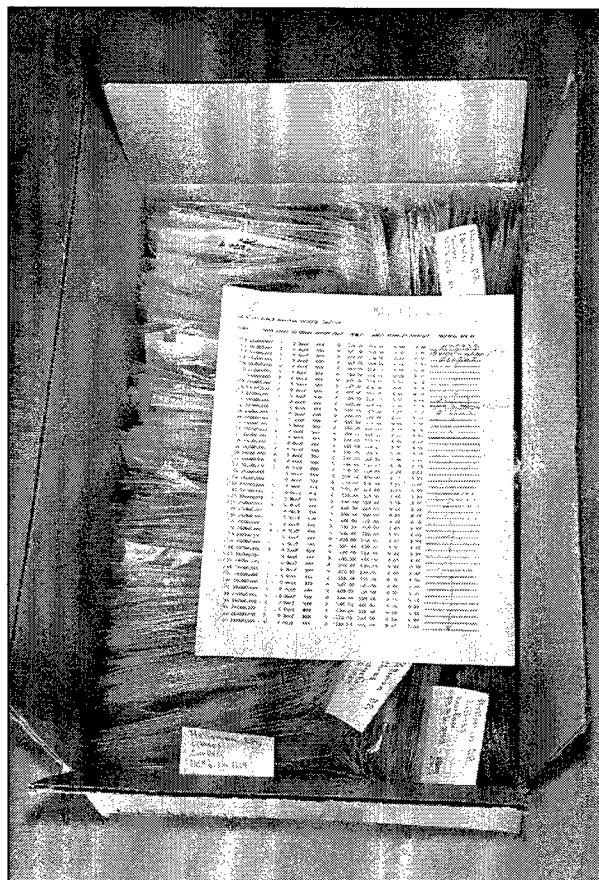
Figure 70. Secondary containers used to house Holloman AFB collections.

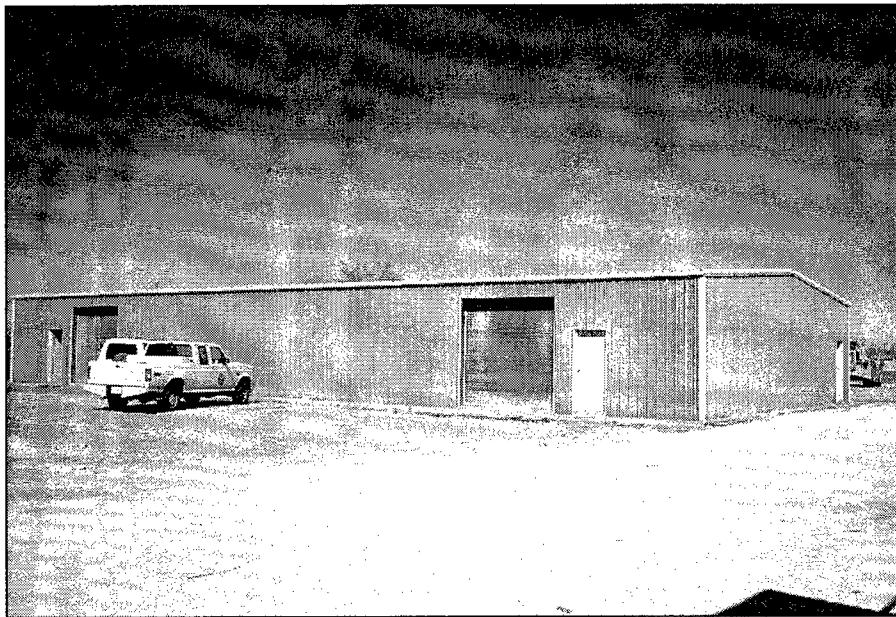
Figure 71. Exterior of the ACA warehouse.

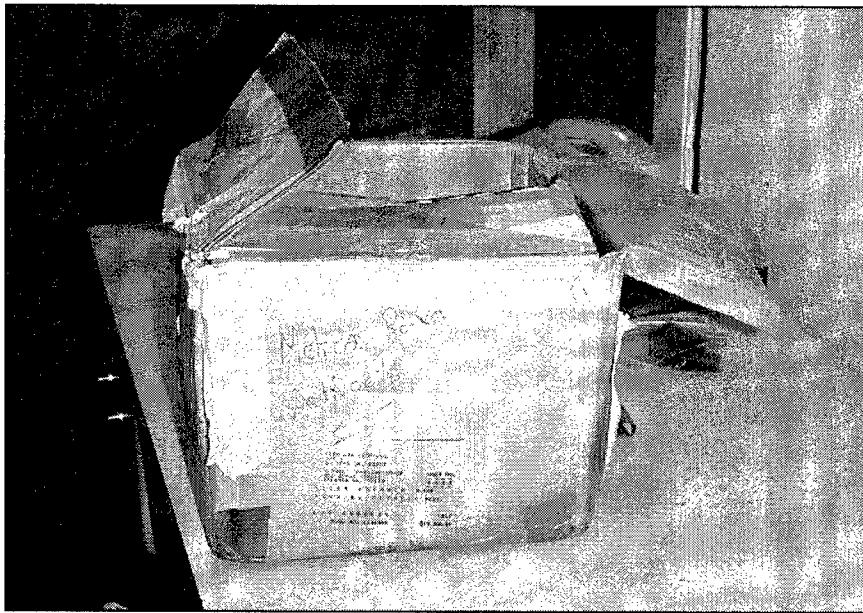
Figure 72. Damaged primary container housing Melrose AFR collection at the time of evaluation.

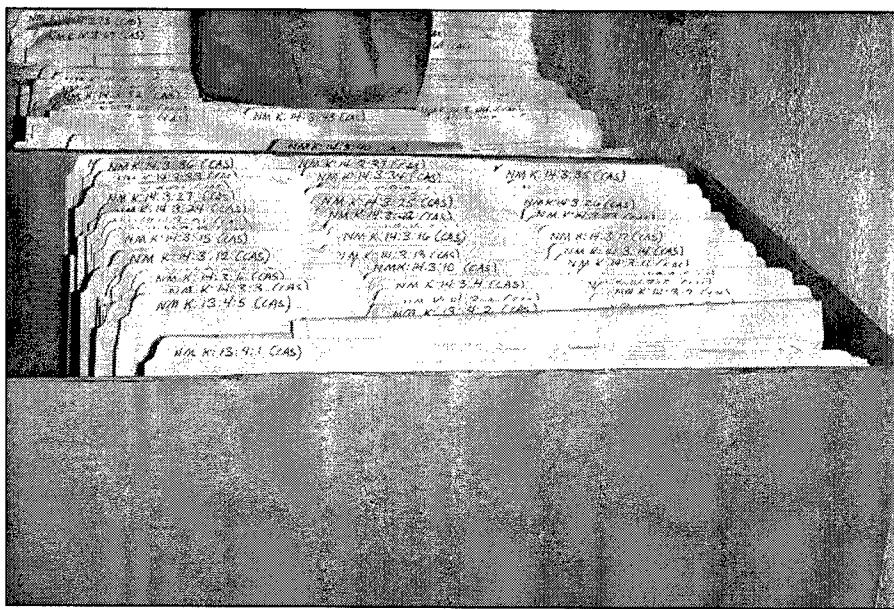
Figure 76. Properly processed associated documentation, which has been placed in acid-free folders labeled in indelible ink.

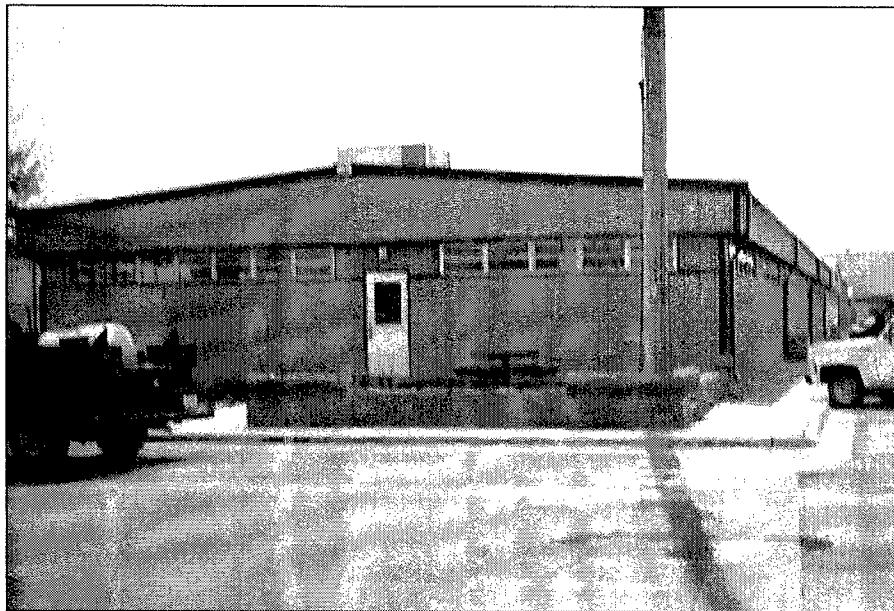
Figure 77. Exterior of the Civil Engineering Building addition housing the Environmental Flight offices.

The offices of the Environmental Flight are located in the Civil Engineering Building (550). This space is actually an addition that was built onto the existing Civil Engineering Building in 1971 (Figure 77). It contains office cubicles and a conference room but has no space allotted for the curation of archaeological collections. Utilities available in this facility include heat, air conditioning, electricity, and telephones. Rest rooms are located in the main portion of the building. After the March 1994 evaluation, the Environmental Flight offices were moved two offices down in the same building. Curation facilities and records are stored in the same manner as during the initial assessment but in a different location.

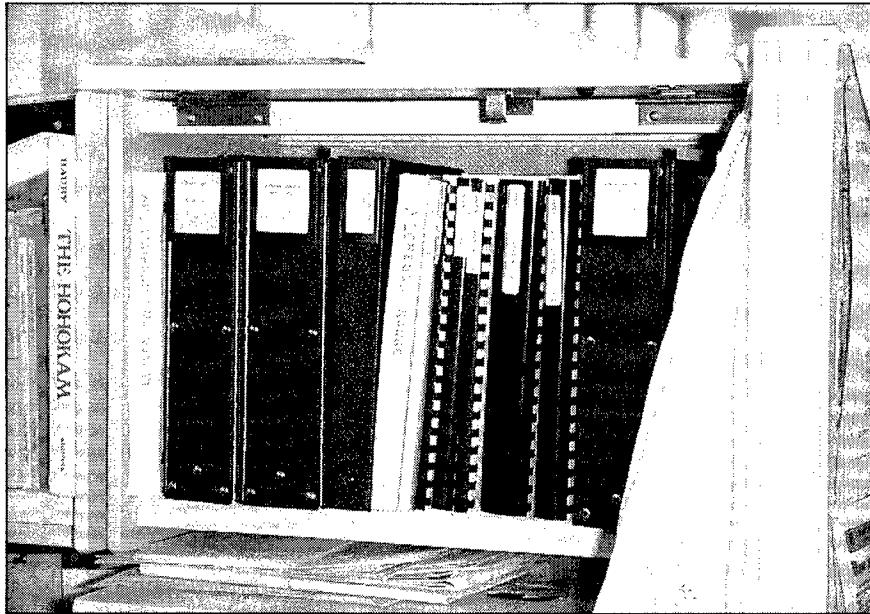
Figure 79. Associated documentation stored on metal shelves in Martyn Tagg's office.

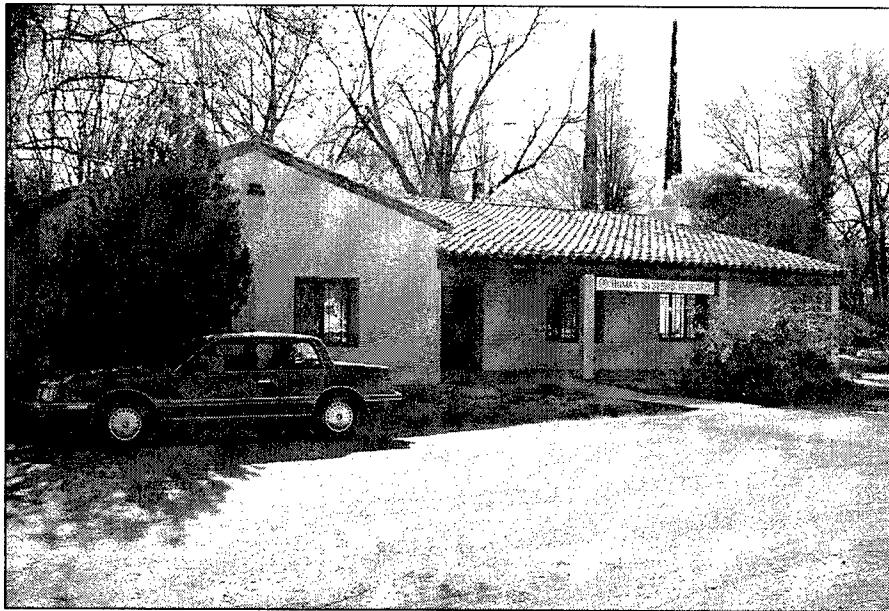
Figure 81. Exterior of the HSR office.

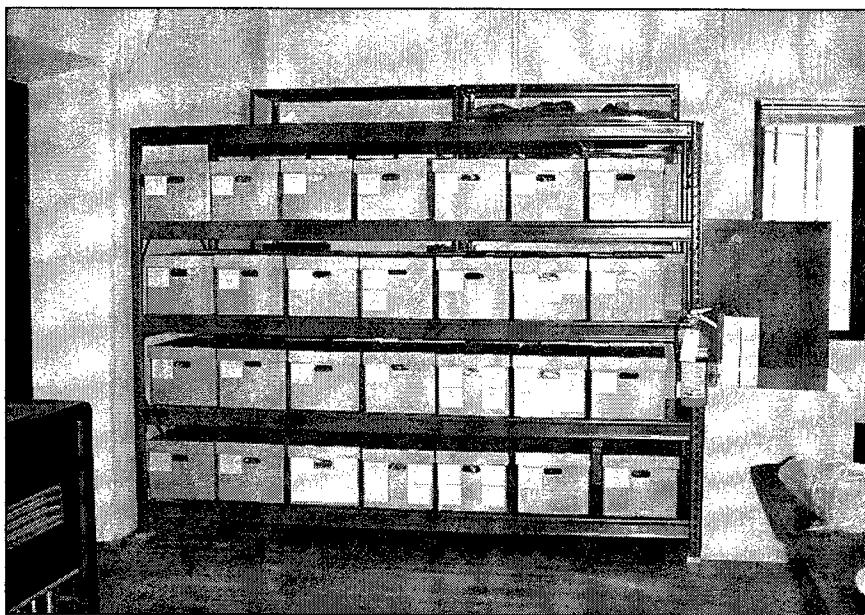
Figure 82. View of HSR collections storage area.

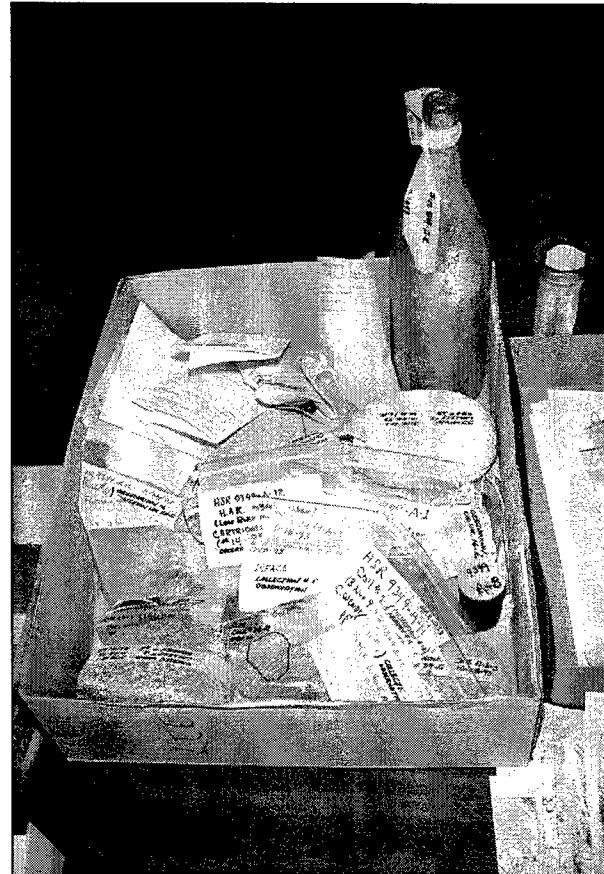
The artifacts from Holloman AFB are temporarily stored in an acidic cardboard box until the collection is processed. No label information is recorded on the box (Figure 83). Once the collection has been processed, the artifacts will be placed in an acid-free box with a telescoping lid. A computer-generated, adhesive label will be placed on the box with the HSR project number and the LOA site numbers of the artifacts housed in the box.

Figure 83. The collection from Holloman AFB was unprocessed at the time of this evaluation, and was stored temporarily in a variety of primary and secondary containers.

A variety of temporary secondary containers are currently housing the artifacts, including plastic zip-lock bags, paper bags, and small cardboard boxes. Some of the artifacts are loose in the primary container. Many of the plastic bags have suffered minor puncture damage. All artifacts have labels associated with them. Labels are written directly on acidic paper in marker. Label information is consistent, but on some of the labels, the marker is smeared, making them difficult to read. Once the artifacts have been processed, they will all be placed in two-mil, plastic, zip-lock bags. In each bag there will be a paper insert label written in marker. All labels will be clear, concise, and consistent.

1. Label all artifacts with india ink to prevent information loss if artifacts are separated from provenience data.
2. Replace secondary containers with four-mil, zip-lock, polyethylene plastic bags, and label with indelible ink. Additional labels should be made from spun-bonded, polyethylene paper (e.g., Nalgene polypaper), labeled in indelible ink, and inserted into the secondary containers.
3. Apply adhesive polyethylene plastic label holders, with acid-free inserts, to the boxes.

- Labels should not be applied directly to the boxes. When label information or box contents change, inserts should be replaced. This method reduces the chance of conflicting and confusing information.

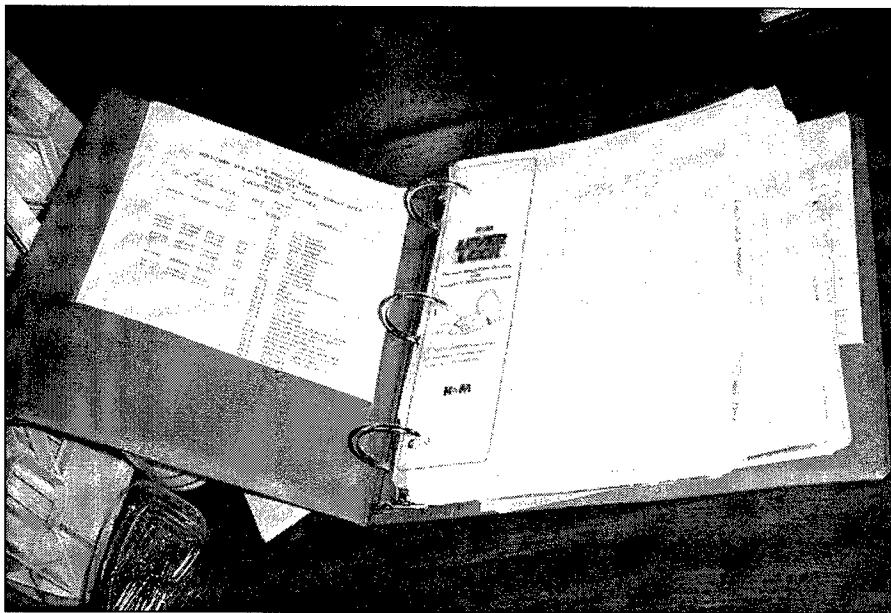
Figure 85. Administrative records for the Holloman AFB collection temporarily stored in nonarchival-quality three-ring binders.

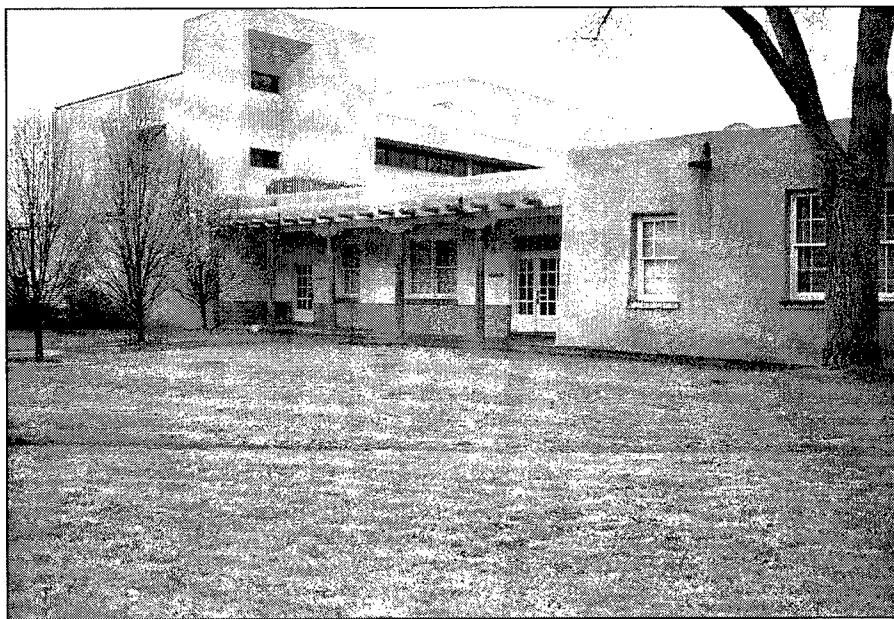
Figure 87. Anthropology Annex on the UNM campus at Albuquerque.

The Anthropology Annex was originally constructed as a science lab in the 1920s or 1930s. Exterior walls are constructed of concrete blocks situated upon a concrete foundation. A built up roof of tar paper and gravel was installed on an unknown date. The roof is solid and free from leaks, but the foundation has several cracks running through the basement laboratory. In 1980 the building was internally renovated and redesignated the Anthropology Annex. Windows are constructed of the original wooden frames, and they show no evidence of leaking either air or water. All windows are shaded and measure

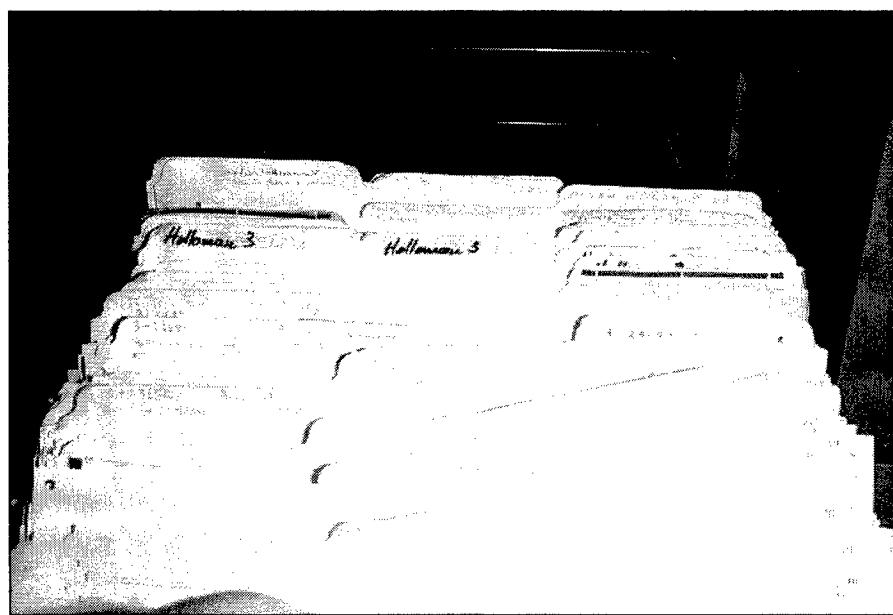
Figure 89. Documentation from investigations conducted on ACC installations is housed in acidic manila folders labeled in a variety of media.

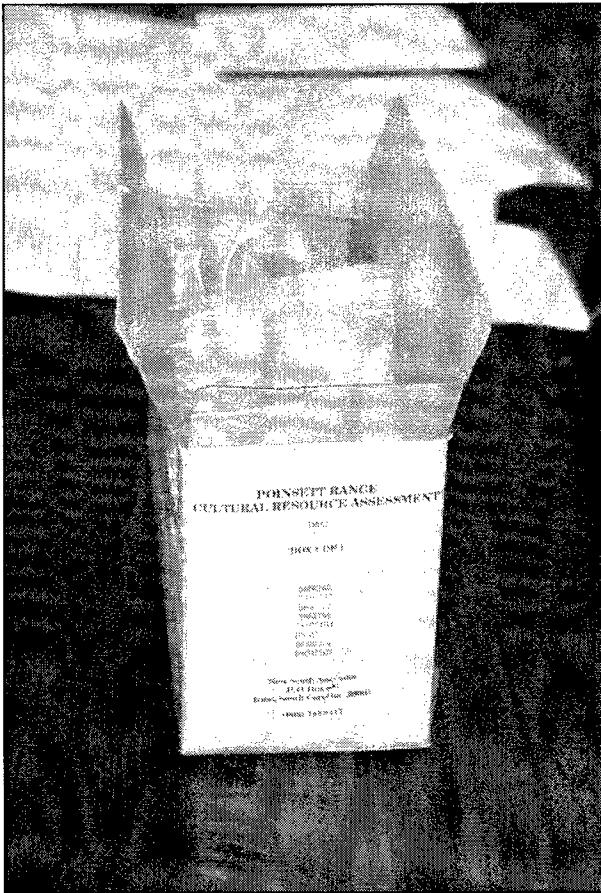
All artifacts recovered from the 1992 New South survey of Poinsett AFR are located in one acidic-cardboard box that measures 15 x 5.5 x 8 inches (l x w x h). The box is labeled directly with a preprinted label taped to the box exterior that contains site numbers, project title, and the address of the investigation firm (Figure 90).

Figure 90. Primary container temporarily housing the Poinsett AFR collection held by New South.

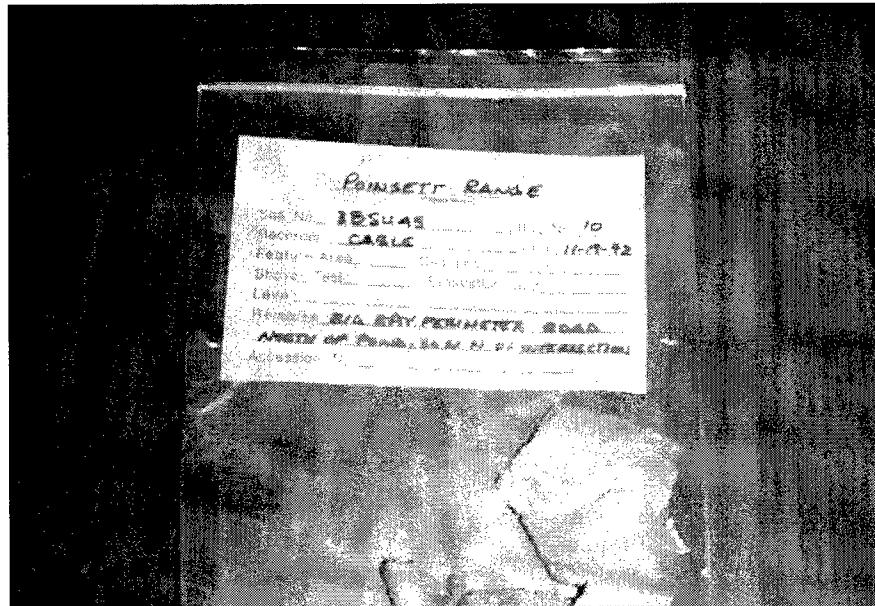
Secondary containers used for the Poinsett Range collections are plastic, four-mil, zip-lock bags (Figure 91). Each contains a preprinted insert, labeled in marker, with site information (e.g., project, provenience).

Figure 91. Secondary container and inserted label used to package the Poinsett AFR collection.

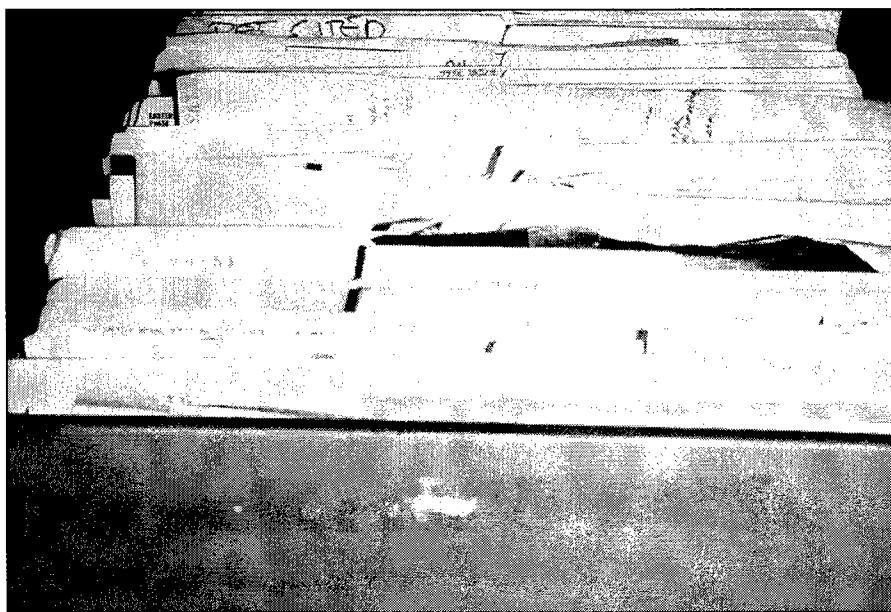
methods: (a) by project number and name, (b) by city/county, and (c) by agency/client name. Acidic manila file folders with adhesive labels serve as secondary containers for paper records. Label information is typed and includes project number and name (Figure 97). Each project folder contains a sheet listing the contents of the specific folder, including any

Figure 97. Associated documentation from Langley AFB is kept in a file cabinet, arranged by project name and number.

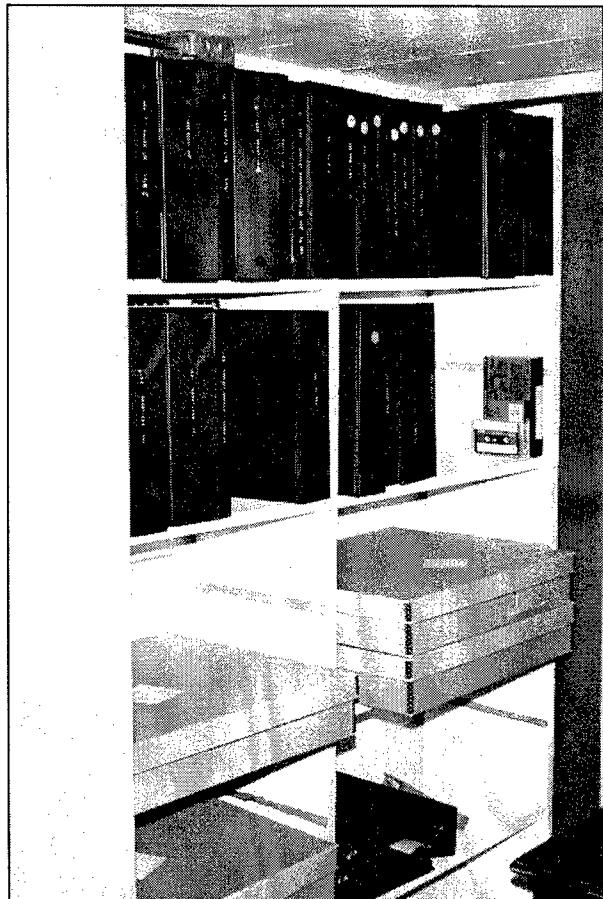
photographic or oversized records stored in other areas (Figure 98). Although the general condition of the records is good, they contain contaminants such as staples and paper clips. None of these records have been duplicated.

Figure 98. WMCAR photograph storage room.
